FOREST PRODUCTS RESEARCH IN PICTURES

NO. 32

STEPS REQUIRE PROTECTION FROM DECAY

FOREST PRODUCTS LABORATORY
U. S. FOREST SERVICE
MADISON, WISCONSIN

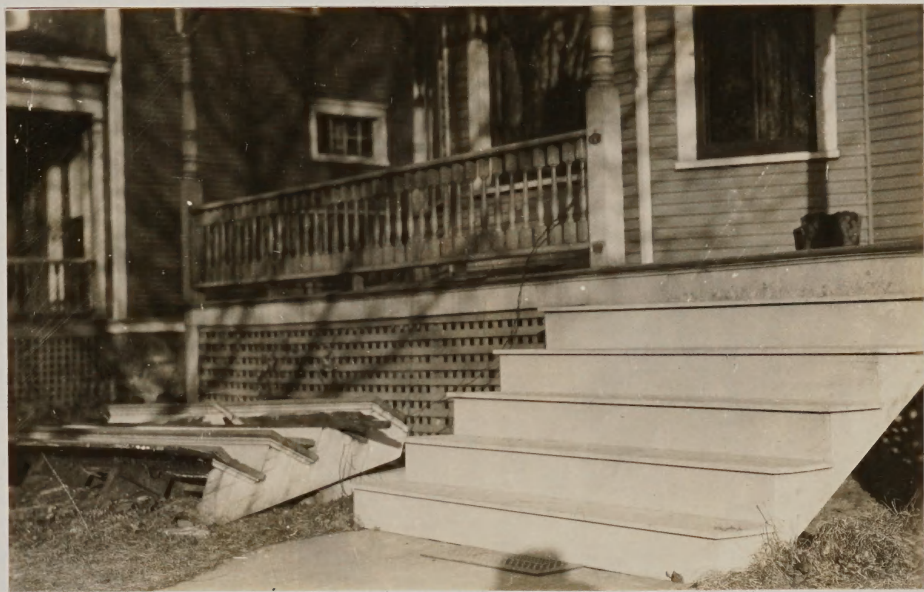
A part of the 4 billion cubic feet of timber used to replace wood destroyed by decay in service last year went into these new front steps.

The old steps, uniform with the rest of the porch construction have rotted away too soon as a result of being placed directly on the ground where they could take fungous infection from the soil and grass.

The new steps, none too well painted and subject to the same conditions, hold out no promise of giving longer service than the old.

The man who wishes to avoid frequent and expensive repairs to steps and porches should eliminate decay favoring conditions. Decay may be combated by such practices as the use of heartwood of highly durable species, elimination of weeds and debris, avoidance of moisture-holding forms of construction, liberal ventilation and drainage, and the use of preservatives wherever practicable.
